Proposed Subdivision
The Fairways – Stage 1
Site Classification

Maison Dieu Road,
Singleton

NEW14P-0046-AG
16 January 2025

**RE: PROPOSED SUBDIVISION – THE FAIRWAYS, STAGE 1
MAISON DIEU ROAD, SINGLETON
SITE CLASSIFICATION (LOTS 101 TO 130)**

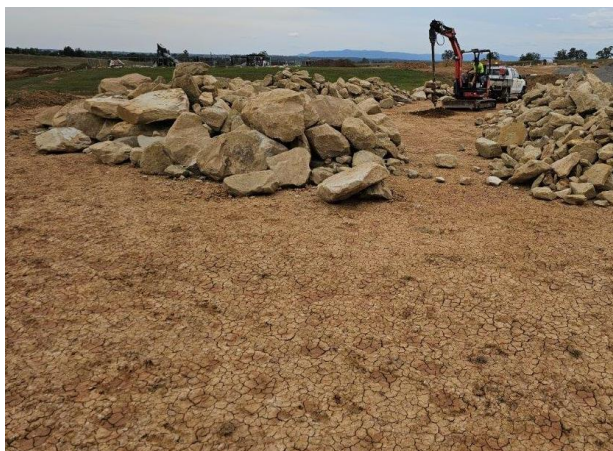
Photograph 1: From near northern boundary of Lot 105, (approx. 15m north of BHQ19), facing south. Showing excavator at BHQ19 location.
